Reliance Home Inspection

Inspection Report Summary

Address: 123 Dream Home Lane

Date: 6/25/05

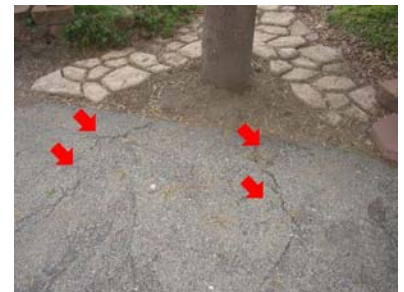
CONDITION: General condition appears serviceable with the exception of the following item(s) listed below. Cracks were noted. We recommend sealing these cracks to prevent erosion. A tree at the edge of the driveway appears to have caused damage to the driveway. The damage may continue unless the tree is removed. We recommend consulting with a licensed arborist.

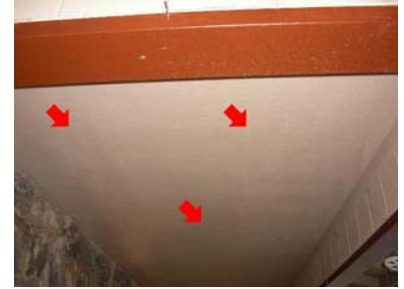
PORCH COVER

General condition appears serviceable with the exception of the following item(s) listed below. The front porch overhang is a soffit type construction without ventilation = installation of ventilation is recommended.

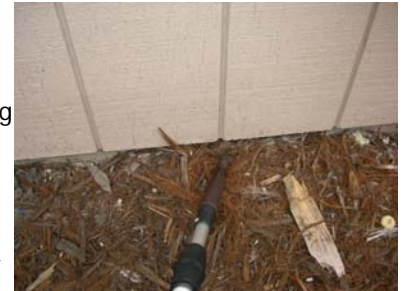
Appear serviceable. The recommended clearance for siding is 6" above soil and 2" above hardscape such as concrete. Trees and or bushes are planted close to the home. The home may be subject to damage from falling debris. This may also be a fire hazard. We recommend trimming bushes and trees away from the home for safety enhancement. Gaps noted in the siding at corner(s) needing sealing to help prevent moisture intrusion = seal with caulking and or trim stock. Lower grade in few areas. Unable to view under the alcove on the left side of the home due to height restrictions.

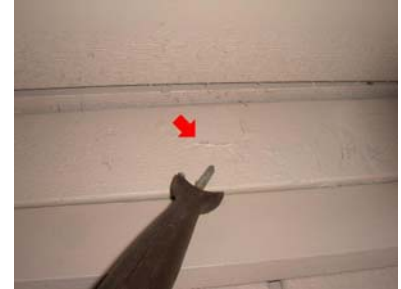
EAVE CONDITION:

General condition appears serviceable with the exception of the following item(s) listed below. Damage or deterioration was noted to the paint or finish in a few areas. We recommend painting.

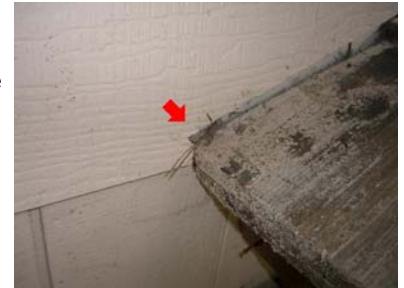
Metal. The general condition appears serviceable with the exception of the following item(s) listed below. Exposed nails were noted on some of the flashings. We recommend sealing the top of the nails with mastic. A proper kickout flashing at the roof to wall connection is not visible. This can lead to water intrusion. We recommend having kick out flashings installed.

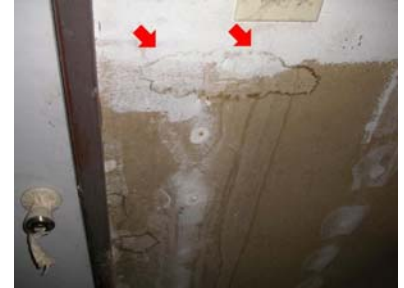
Appears serviceable. Walls of the garage were not fully visible due to stored items. Moisture stains were noted on the wall(s) of the garage.

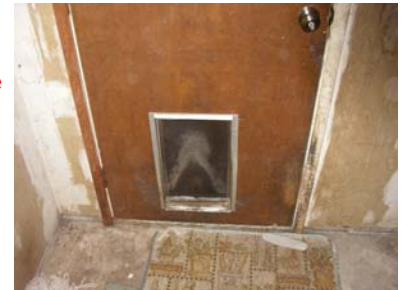
Appears serviceable and is a solid core or metal type door. Self closer is functioning properly. **Pet door penetrates through the door. This compromises the fire rating of the door. This is a safety hazard.** Correction is recommended.

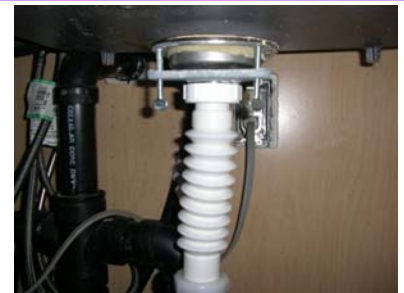
The general condition appears serviceable with the exception of the following item(s) listed below. An improper flex type drain line was noted. This type of fitting is not approved by the UPC. Debris can get caught in the ribs of this type of drain line. We recommend installing an a UPC approved drain line.

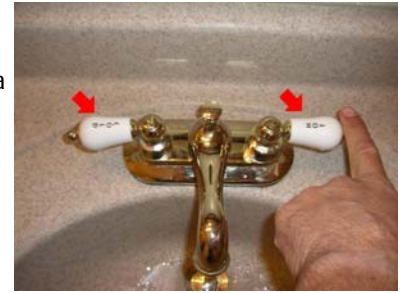
CONDITION OF SINK:

Hot and cold were reversed at the sink faucet. This is a potential safety hazard. Correction is recommended. Even though the valves are labeled as such this is still a safety hazard and correction is recommended.

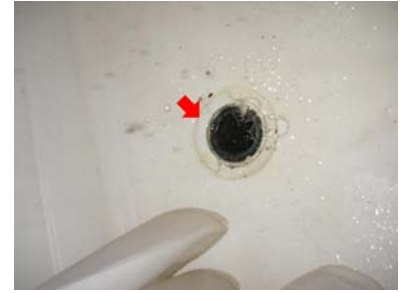
TUB/SHOWER PLUMBING FIXTURES:

The drain cover/screen is missing in the shower, there is a possibility of moisture entering around this area = We recommend further evaluation and repairs by a licensed plumbing contractor.

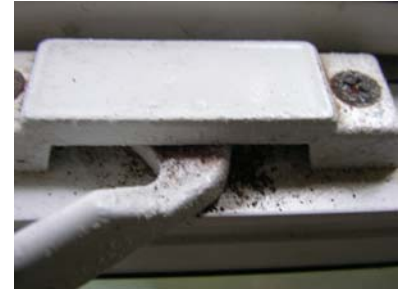
WINDOW LOCKS:

The locks were missing or did not function properly at the following window(s): Middle bedroom and master bathroom locks inoperable = repairs needed. Corrosion noted on the window locks in the bedroom alcove.

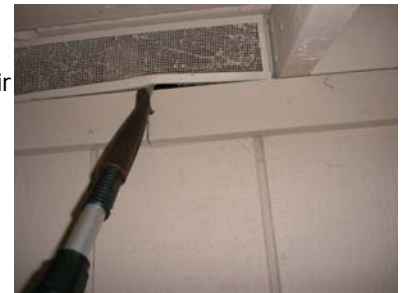
VENTILATION:

The general condition appears serviceable with the exception of the following item(s) listed below. Screen(s) noted to be bent creating an opening = repair to help prevent pest entry.

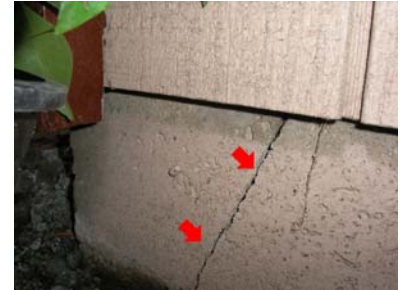
Cracks noted = monitor for and changes in size or differential.

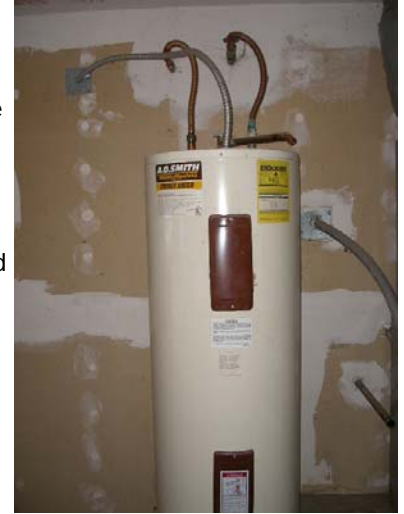
No straps installed. This is a safety hazard. We recommend a metal strap wrapped completely around and fastened to the studs on either side at the top 1/3 and bottom 1/3 of the unit. If the unit is away from the wall, a block for behind the unit is also recommended so that the unit does not move. We recommend installing blocking behind the unit to keep it from moving backward during an earthquake. We recommend further evaluation and repairs by a licensed plumber. Concrete protection bollard(s) should be installed in front of the water heater to protect the unit from physical damage from vehicle(s). Electrical cover missing at the top of the unit = replace.

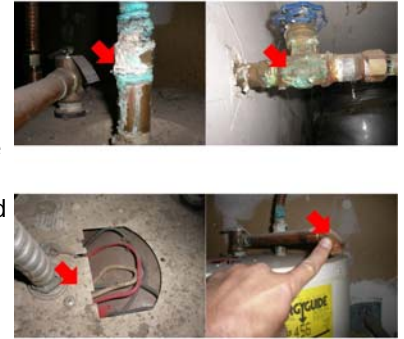
The pressure relief valve drain line was missing or ended prematurely. This is a safety hazard, correction is needed. We recommend correction by a licensed plumbing contractor. Corrosion was noted on supply valve(s) above the water heater. This may be an indication that the valve(s) have leaked in the past. We recommend attention, repair or monitoring. We recommend further evaluation and repairs by a licensed plumber.

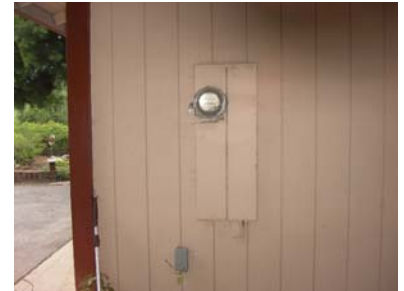
MAIN PANEL & SHUT OFF LOCATION:

Breakers are without the benefit of proper labeling. The grounding electrode was not visible at the time of our inspection. Corrosion is noted within the electrical panel. No lock was installed on the panel cover. This is a safety hazard for children who might mistakenly touch the internal components of the panel and receive a shock. We recommend the installation of a lock for safety enhancement. The dead front cover is a type which does not have screws to keep the dead front cover in place. This can be a safety hazard for children who could open the panel. We recommend the installation of a lock or screws which will make the removal of the dead front cover difficult for children.

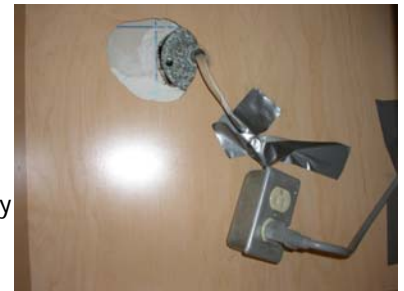
OUTLETS:

A representative number was tested and the outlets generally appeared serviceable. A loose outlet was noted in the left rear bedroom. Correction is recommended. Open ground left front and rear bedroom. Outlet dangling in the cabinet above the microwave = repair needed. Outlet located underneath the main electrical panel, the cover does Not fit properly the interior of the box is exposed = repair needed.

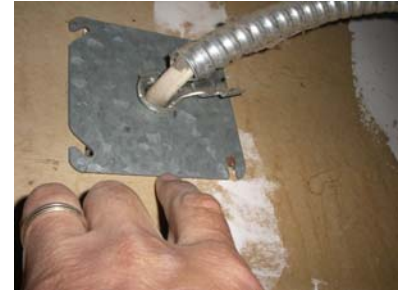
GARAGE WIRING NOTES: Clamp missing from the armored cable for the water heater connection = repair needed.

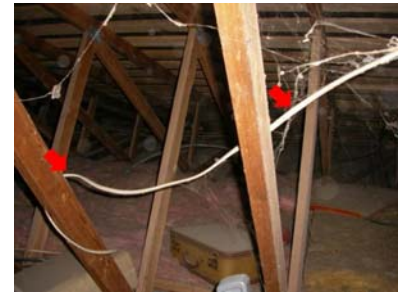
WIRING NOTES: Conductor(s) noted in various area(s) that should be reinstalled properly = safety hazard.
