Reliance Home Inspection

Inspection Report Summary

Address: 456 Santa Cruz Dr.

Date: 06/17/2005

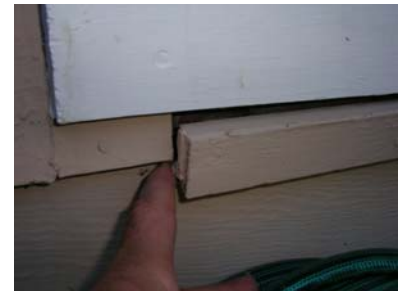
General condition appears serviceable with the exception of the following item(s) listed below. No flashings were visible above the window and door trim. This is typical on older homes. They rely on caulking to prevent intrusion. We recommend monitoring the caulking at the trim to wall connection and re-caulking when necessary. Loose trim was noted at the front of the home. We recommend repair. We recommend repair.

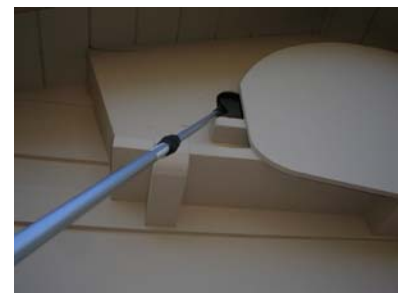
The eaves, soffits & trim generally appear serviceable. The decorative area above the garage should be screened off to prevent birds from nesting.

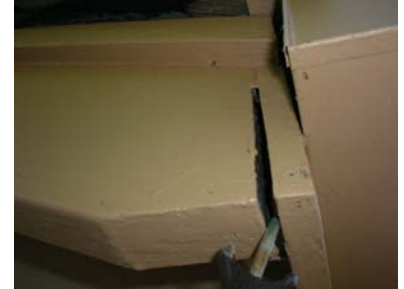
General condition appears serviceable with the exception of the following item(s) listed below. Fascia noted to be separating from the eave(s) in a few areas = repairs needed.

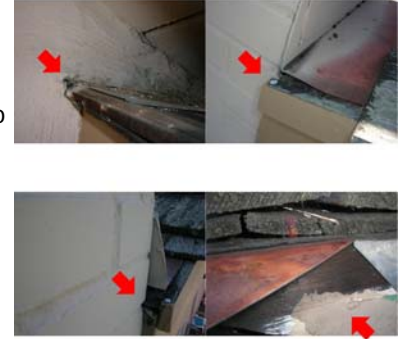
Metal. The general condition appears serviceable with the exception of the following item(s) listed below. Chimney, eave, transition flashing(s) inadequate exposed area(s) for possible moisture intrusion = repairs needed. A proper kickout flashing at the roof to wall connection is not visible. This can lead to water intrusion. We recommend having kick out flashings installed.

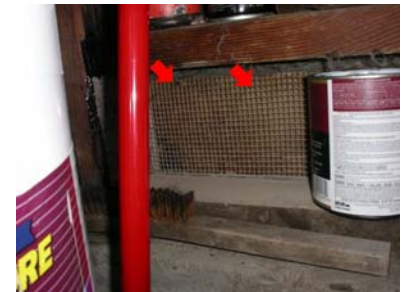
The general condition appears serviceable with the exception of the following item(s) listed below. The vent(s) in the garage were covered. We recommend removal of the cover to allow for proper ventilation of the garage. Unable to evaluate due to storage of personal items.

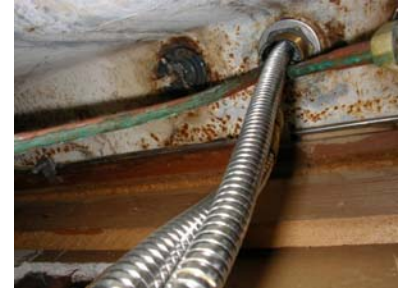
Faucet is serviceable. The general condition appears serviceable with the exception of the following item(s) listed below. Corrosion noted on the pipes below the sink. Typical marring noted from usage. Caulking recommended for the sink to counter connection.

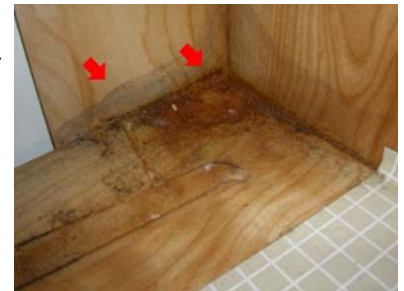
Moisture stains were noted below the kitchen sink. We recommend monitoring in the future. Storage of items. Hole(s) noted in wall under sink area = recommend sealing to keep out vermin.

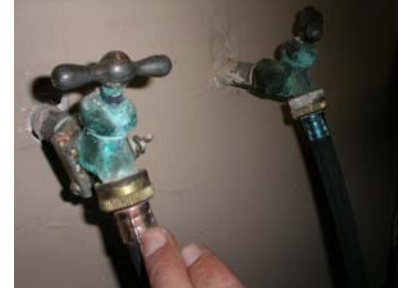
PLUMBING: Corrosion is noted on the laundry valves. We recommend monitoring.

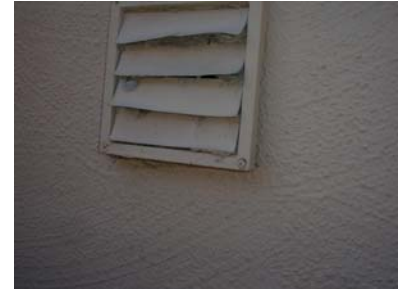
VENTING: Dryer venting is provided. The general condition appears serviceable with the exception of the following item(s) listed below. The ducting louver stays open = repair/replace. There is a second exhaust duct termination on the left side of the home that is open to vermin entry = repair.

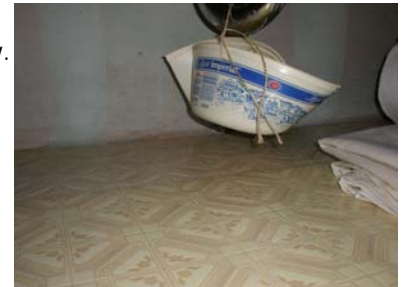
CONDITION OF SINK: Caulking is recommended for the sink to counter connection. The drain stopper did not operate properly. We recommend repair. Corrosion noted on the supply plumbing below the sink. There is a plastic margarine bowl tied up under the sink drain = repairs needed.

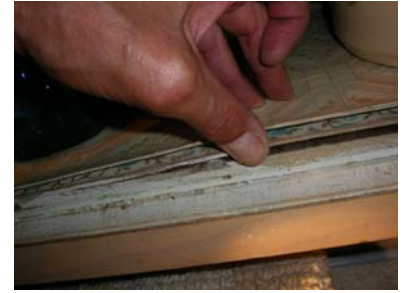
Damage was noted to the cabinet below the sink.

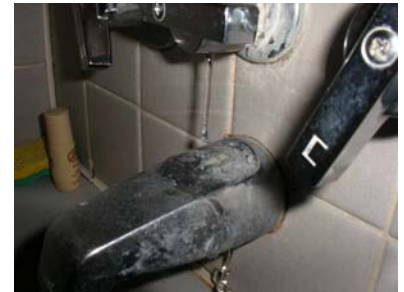
Corrosion noted on the plumbing fixture(s) and the fixture(s) leak = repairs needed.

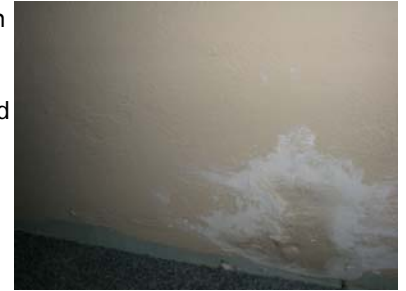
MATERIAL & CONDITION: Drywall. The general condition appears serviceable with the exception of the following item(s) listed below. Damage was noted to the wall in the living room. We recommend repair. Peeling wallpaper in the hallway and master bathroom noted.

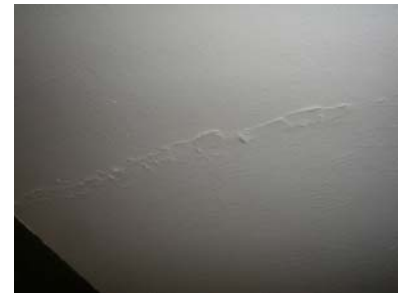
TYPE & CONDITION: Seams visible right front bdrm and Family room. General condition appears serviceable.

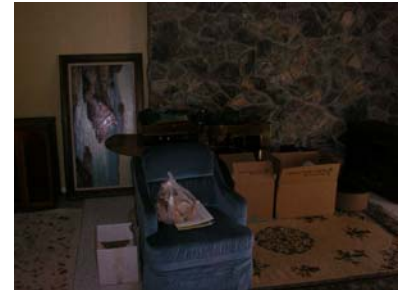
CONDITION: Unable to evaluate to due storage of items and furniture = inspector not allowed to move such items. We recommend cleaning and inspection by a qualified fireplace contractor before use due to inability to view fire box and limited view caused by chimney cap and screen above.

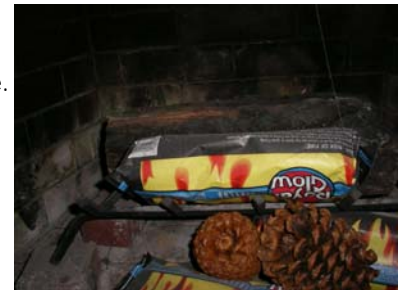
CONDITION: Damper is operational. Cracked/Loose/Damaged Fire Brick. Items evaluation. We recommend cleaning and inspection by a qualified fireplace contractor before use. Limited view due items in fireplace.

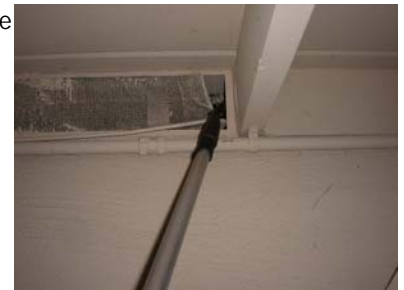
There appears to be minimal ventilation in the attic. The installation of additional vents is recommended. The screen for the gable end ventilation is deteriorated and screen(s) damaged = repair/replacement to help keep vermin out.

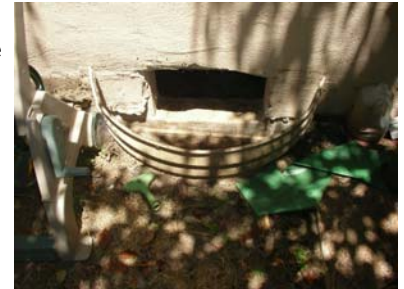
Crawl space is fully accessible. The door to the crawlspace was located on the exterior right side of the home. Deterioration was noted to the crawlspace door. We recommend repair.

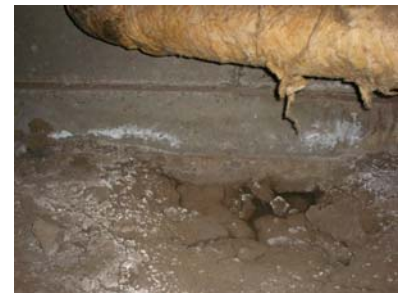
Appears serviceable. The floor of the crawlspace was dry at the time of our inspection. The floor of the crawlspace was dry at the time of our inspection. The general condition appears serviceable with the exception of the following item(s) listed below. Efflorescence and some erosion noted on the foundation at the right front area of the home; this is most likely being caused by the planter at the front of the home = recommend moisture barrier between the foundation and the planter.. This is a white substance which forms on some foundations but causes no damage. Some piers and posts are out of plumb. Moisture noted on the outside wall(s), most likely from the high grade level = lower grade and monitor.

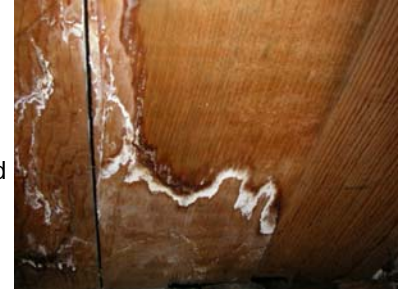
Moisture stains and or corrosion noted to the plumbing were noted in the sub-floor below the hallway bathroom, master bath and laundry drain areas. Wood which is exposed to water will typically attract pests or rot. Correction of the moisture cause is needed. We recommend further evaluation and repairs by a licensed contractor.

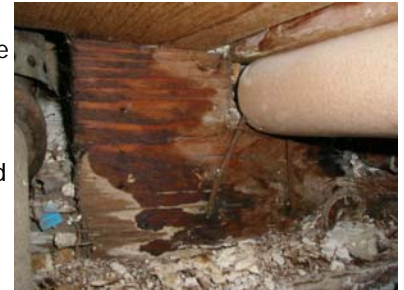
The general condition appears serviceable with the exception of the following item(s) listed below. Moisture stain(s) noted to the rim joist which is the outer most floor joist these areas appear to be affected by the waste plumbing like the laundry drain etc. We recommend further evaluation and repairs by a licensed contractor.

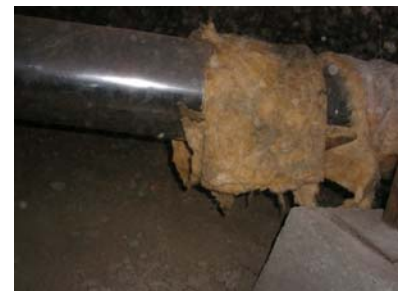
Insulation hanging off of the HVAC ducting = repair/replace.

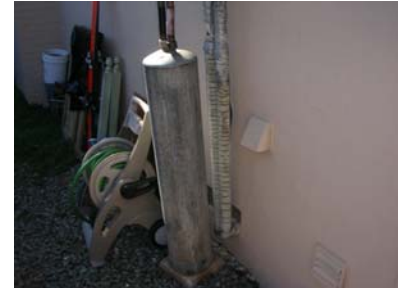
55PSI. This is within the normal range of between 40 and 80 PSI. Client mentioned water flow Not to their liking, there is a Culligan tank in the left side yard they might be restricting some of the flow to the home, this tank is not secured = safety hazard. The Culligan tank is beyond the scope of this inspection.

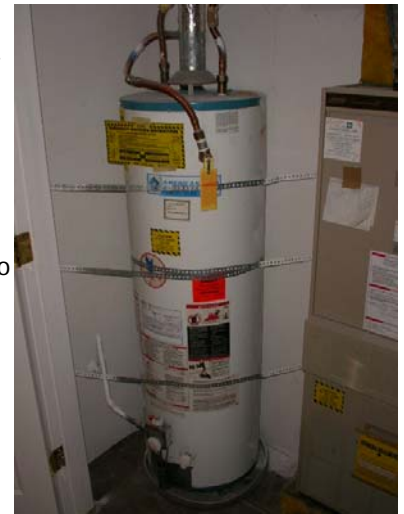
Interior closet. Current safety standards prohibit the installation of gas burning appliances in interior closets. We recommend having the closet further evaluated for the sufficient seal at the bottom of the closet doors to prevent combustion gases from entering the home and for sufficient combustion air for the appliances within this area including the furnace. The other option would be to relocate all gas appliances to a safer location. There is a vent in the ceiling, but it appeared to be blocked.

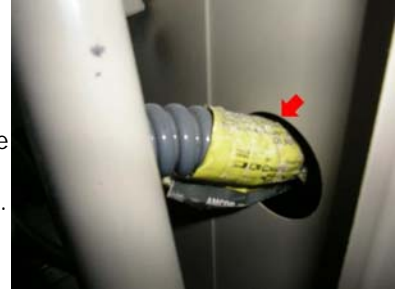
The general condition appears serviceable with the exception of the following item(s) listed below. The unit did not appear to have been cleaned or serviced recently. We recommend cleaning and servicing by a licensed heating contractor. The furnace was very close to the walls of the closet or compartment. It may not meet the manufacturers minimum installation set backs. We recommend reviewing the manufacturers installation instructions to determine if the unit has the proper setbacks. The gas flex line is routed through the housing, this is a safety item and should be corrected to a solid pipe. In the case of seismic activity the flex line can rupture. This is an older furnace and does Not have a safety cut-off switch for the removal of the housing panels = installation recommended and caution needed when opening to change the filter or for any other reason make sure furnace is turned OFF.

In the case of seismic activity the flex line can rupture. This is an older furnace and does Not have a safety cut-off switch for the removal of the housing panels = installation recommended and caution needed when opening to change the filter or for any other reason make sure furnace is turned OFF.

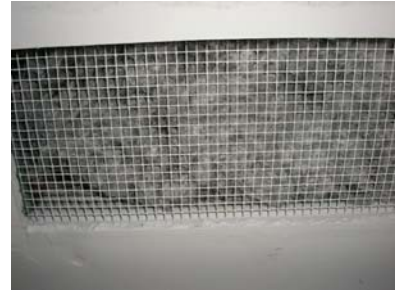
Appears to be blocked. Further evaluation needed.

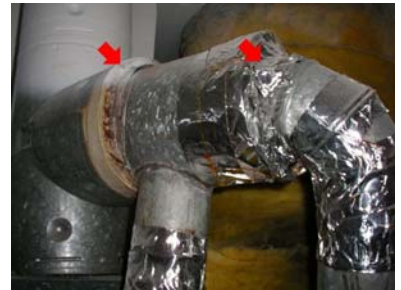
Asbestos like wrap was noted on seam(s) of the vent pipe. This is a potential health hazard. We recommend testing of the wrap to determine if it contains asbestos. If the wrap does contain asbestos, we recommend removal by an abatement contractor. Not sealed properly.

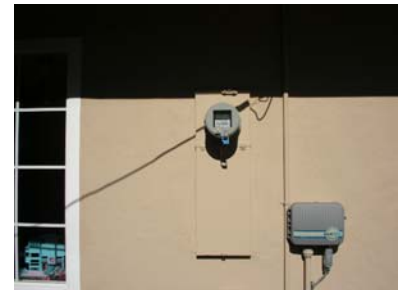
Located at the exterior rear of the home.

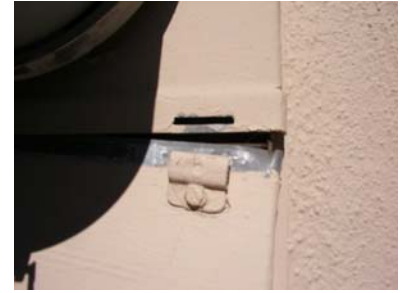
The general condition appears serviceable with the exception of the following item(s) listed below. Cover loose repair. The ground was noted to be connected only to the water supply plumbing, this is no longer accepted as a stand alone ground = installation of a proper ground system such as an approved rod is recommended by a Qualified Licensed Electrical Contractor.

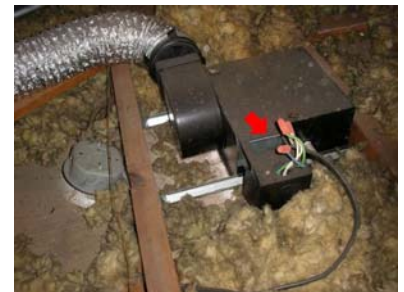
Exposed splice(s) were noted in the attic. Current standards call for all splices to be made inside a closed junction box. This is a safety hazard. We recommend the installation of junction boxes for these splices.

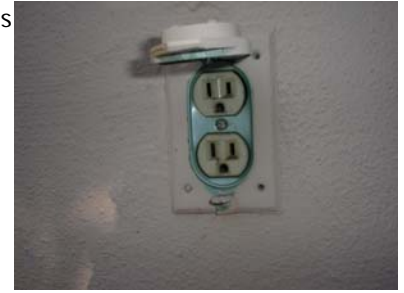
A representative sampling of switches, outlets and lights were tested. As a whole they appeared to be in serviceable condition. **There are no GFCI outlets installed at the exterior. This is a safety hazard.** This type of outlet has a circuit breaker which will shut off the flow of electricity in the event of a ground fault. This means they shut off if you get shocked. Although GFCI outlets may not have been a requirement when this house was built, we recommend upgrading for safety enhancement. A spotlight located at the front of the home is disconnected .
